Volume II-Problem Area Analysis

Luzerne County Act 167 Phase II

Stormwater Management Plan

June 30, 2010

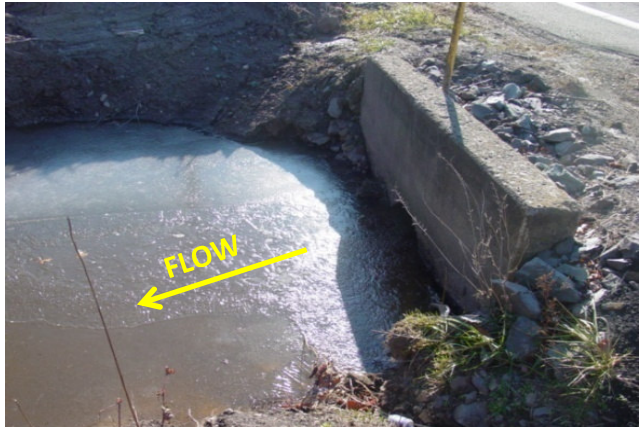
</div> <div style="width: 50%; padding-left: 10px;"> <p>Outlet of downstream culvert under Nuangola Road. The culvert opening is almost completely submerged, indicating a shallow downstream gradient.</p> </div>

Solution	5.4.2, 6.7.1, 6.4.8, 6.A, 6.B
----------	-------------------------------

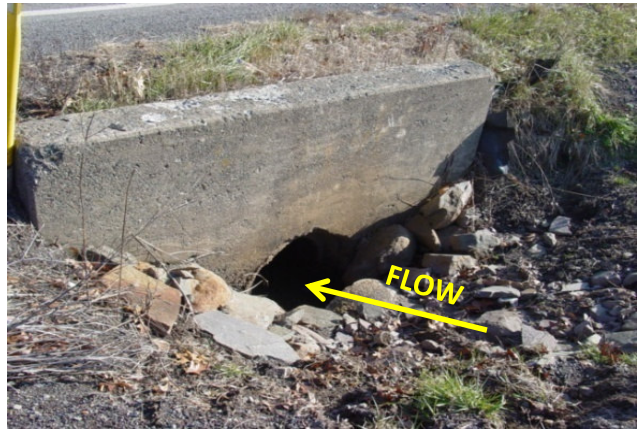
</div> <div style="width: 50%; padding-left: 10px;"> <p>Inlet to upper culvert under Storm Street. There is debris near the culvert opening, restricting the flow of stormwater.</p> </div>

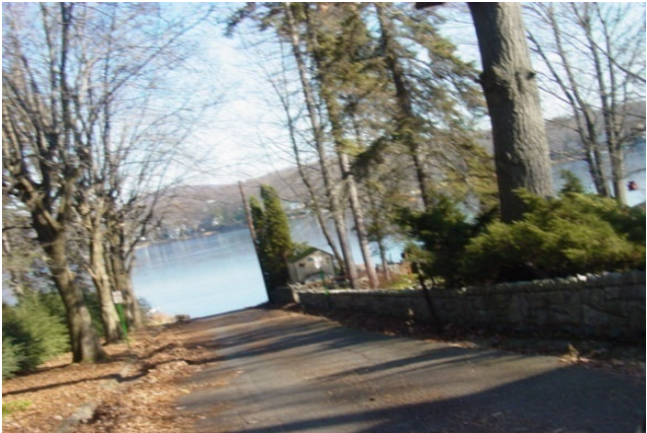
Description
	<p>Looking towards Nuangola Lake. Swales are located along both sides of the roads. Due to the steep grade towards the lake, soil erosion is a possibility.</p>

Solution	5.9.1, 6.4.5, 6.4.8, 6.A, 6.B
----------	-------------------------------

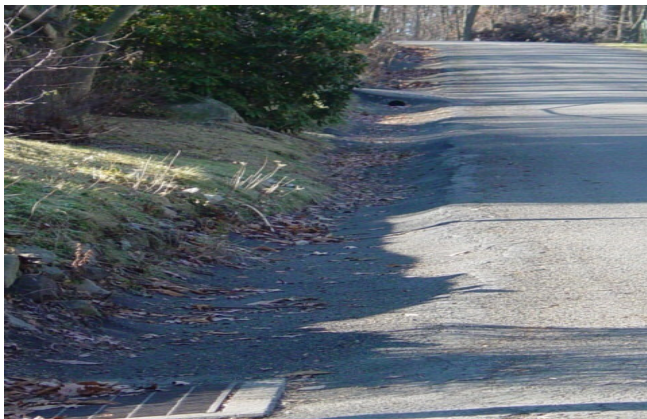
Description
	<p>Looking uphill at drainage swales and sewer system. Further uphill a culvert is in place. Local residents informed us that the swales were recently widened and that flooding has not been a problem since the renovations. Prior to the renovations, flooding occurred upstream of culvert and storm sewer inlets. Note the elevation of the inlet rim in the foreground. Runoff may bypass this inlet.</p>

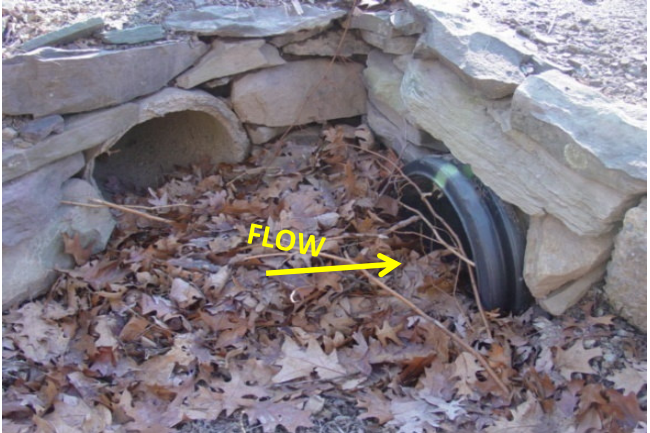
<div style="margin-left: 20px;"> <p>The older RCP culvert on the left is under Willow Grove Street. The newer HDPE culvert on the right passes under Nuangola Road. Leaves, debris, and sediment appear to block the culverts. Water flows left to right.</p> </div> </div>

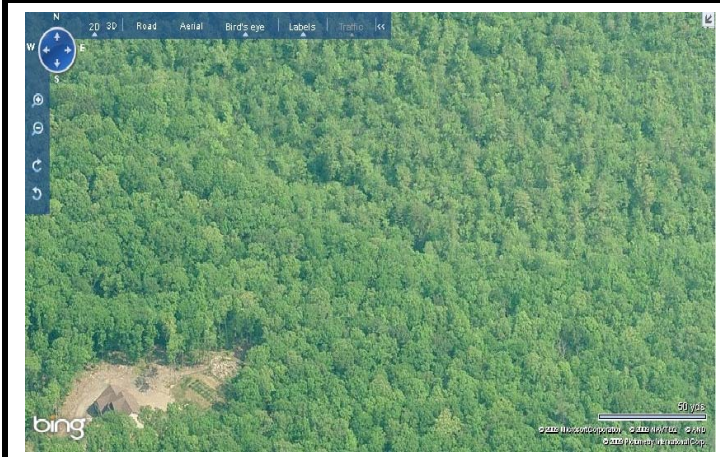
Description
	This site was located in the middle of the woods off a private driveway. Numerous private property signs were noted and no field observations were completed for this site. Based on the aerial photography, only one structure is in the vicinity of the problem area.

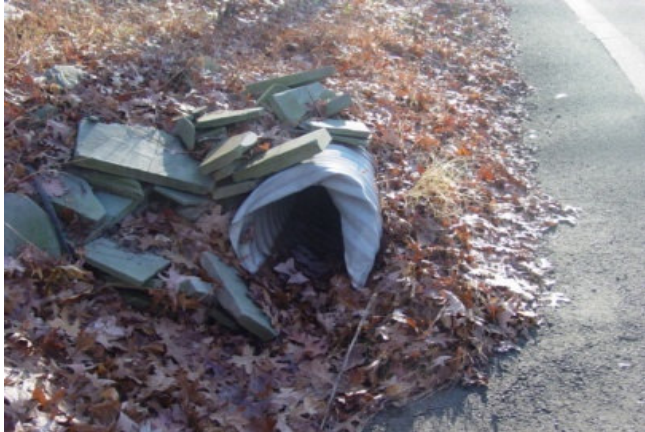
</div> <div style="width: 5%;"></div> <div style="width: 50%; padding-left: 10px;"> <p>Roadside swales had a slight buildup of leaves but seemed to be running clean. No significant problems could be located.</p> </div>

Solution	6.B
----------	-----

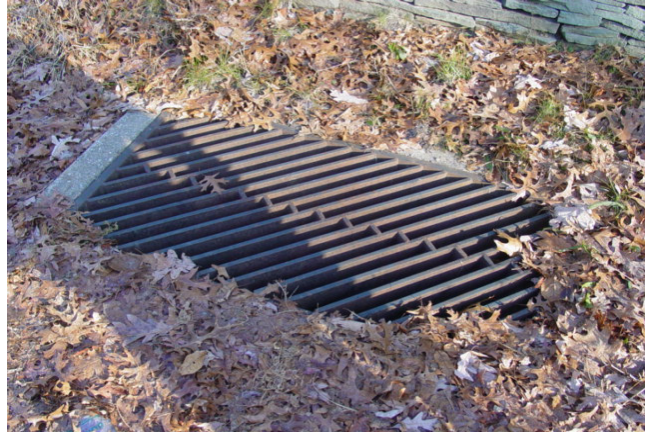
</div> <div style="width: 5%;"></div> <div style="width: 50%; padding-left: 10px;"> <p>This photo indicates that the inlet looks like it has the potential to become clogged with debris.</p> </div>

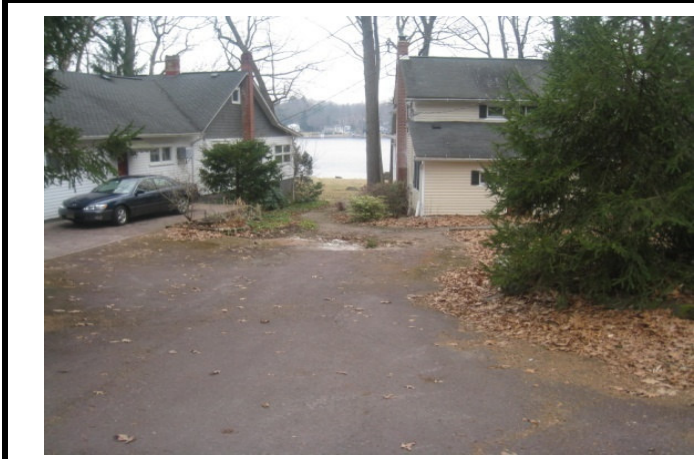
This photo was taken looking at Nuangola Lake from stated problem area. Overland flow to the lake may be occurring, causing the noted flooding.

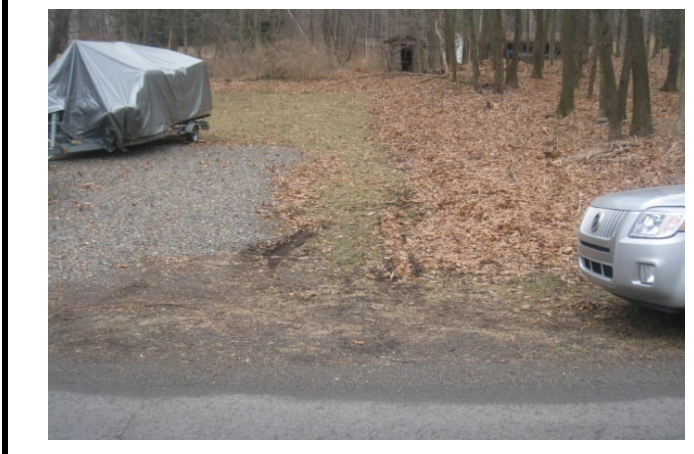
Looking uphill from problem area. There does not appear to be any stormwater conveyance facilities in this area.

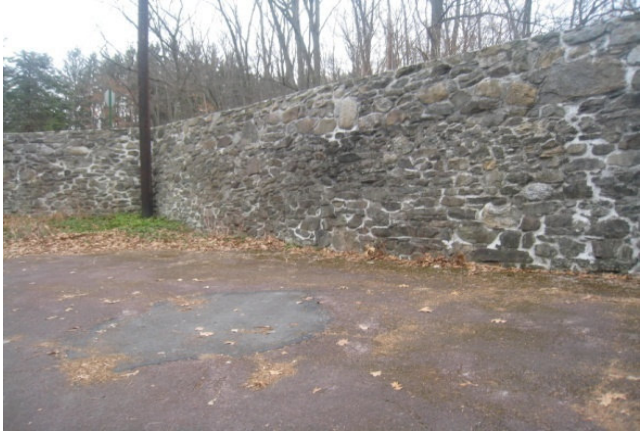
<div style="margin-left: 20px;"> <p>Large retaining wall along low side of Nuangola Ave. The top of the wall is lower than the grade of Nuangola Ave. It is believed that stormwater carrying sediment across the road would be deposited in the area at the base of the wall.</p> </div> </div>

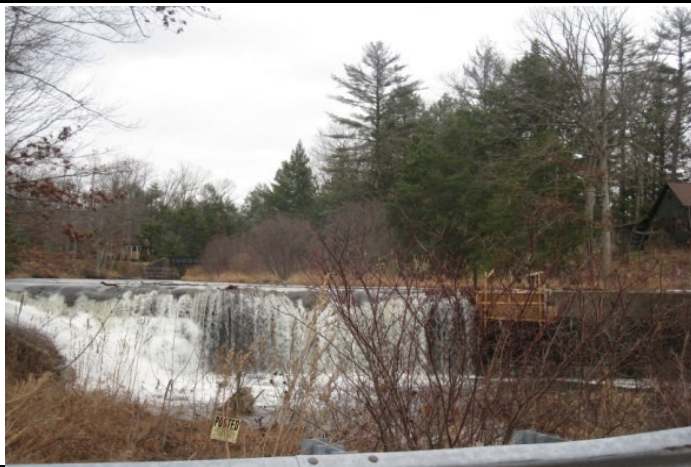
Description
	Looking upstream at the dam from the bridge on Blytheburn Road.

Solution	5.4.1, 5.4.2, 5.6.3, 6.7.1, 6.A, 6.C
----------	--------------------------------------

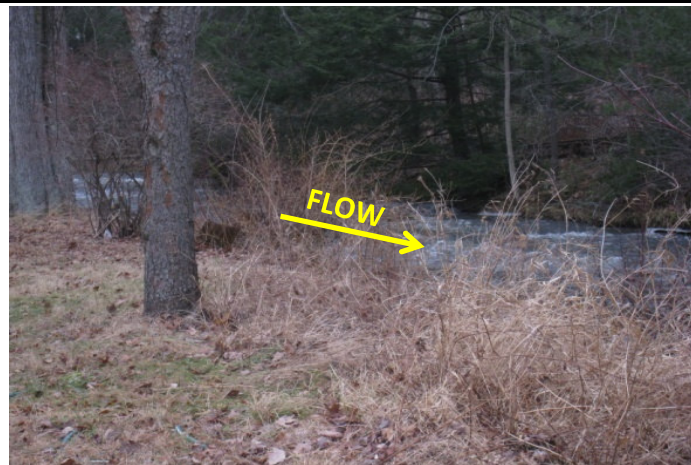
Description
	Wapwallopen Creek looking downstream of bridge along the trailer park. No buffer is present along the right bank. High streamflows will leave the bank towards the trailer park due to the steeper left bank.

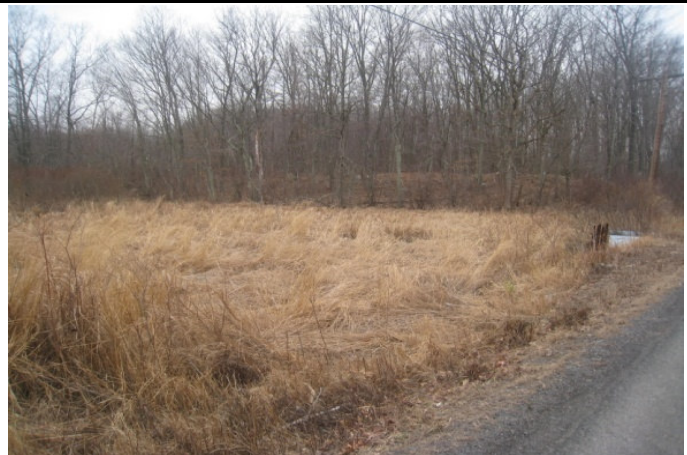
<div style="padding-left: 10px;"> <p>The road grade is only slightly above the floodplain. As such, the road probably floods during high rainfall events.</p> </div> </div>

Solution	5.4.2, 6.7.1, 6.A, 6.B
----------	------------------------

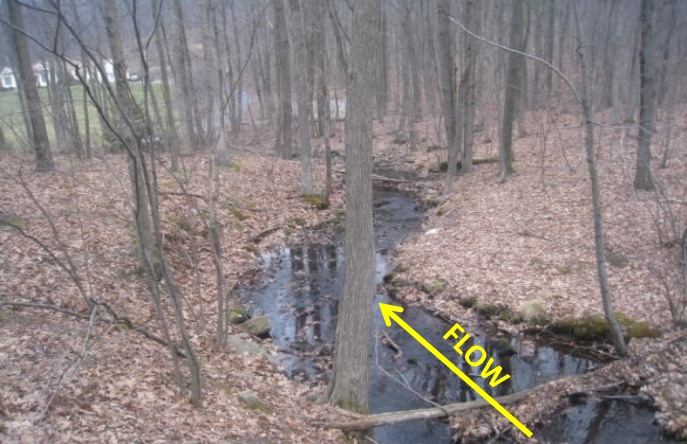
Description
	Looking downstream. The home experiencing flooding is in the right foreground. The channel is relatively small yet is well defined. Dimensions are approximately 1 foot deep and 3 feet wide. The upstream residential development drains to this channel. No stormwater basins were noted in the upstream development.

Solution	5.4.2, 5.6.3, 6.4.5, 6.A, 6.B
----------	-------------------------------

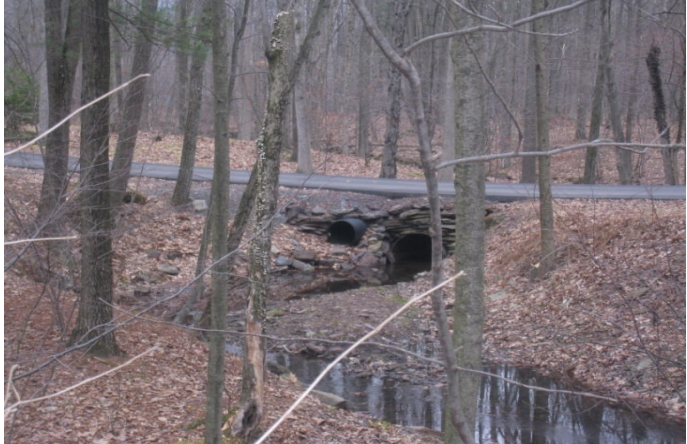
Description
	Outlet of culverts underneath private drive. The channel turns sharply below the culvert, with sedimentation deposits on the inside of the bend. The culvert appears undersized since a secondary culvert appears to have been added to increase capacity.

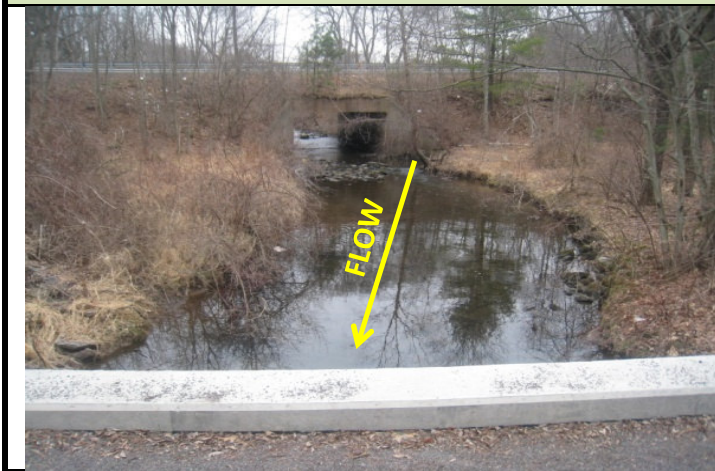
Looking upstream at the bridge under Church Road. Channel is clean and well defined. Buffer is present on both sides of the channel.

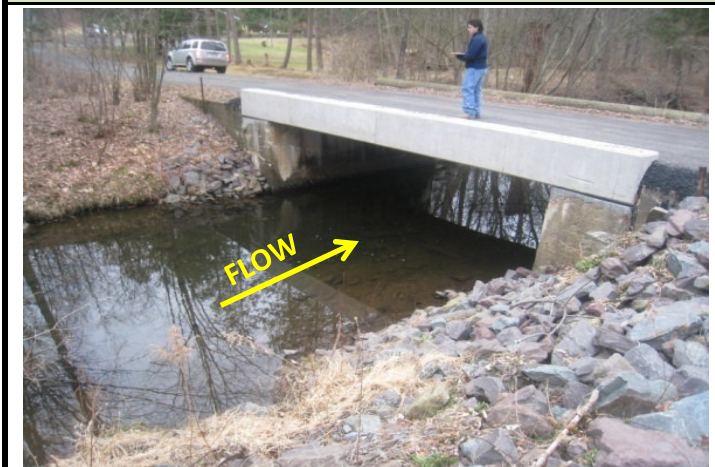
Downstream bridge to private resident. Waterway opening is smaller and low chord lower. Concrete beam/curb has recently been added to existing abutments. High storm events most likely cause backwater and overtopping of the bridge.

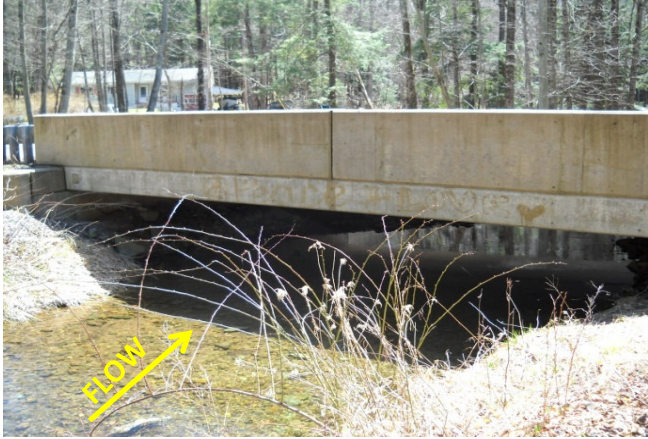
<p>Looking downstream at upstream face of Old State Road bridge. Bridge low chords are approximately 3 feet above the bottom of the channel. Sedimentation along both banks at the upstream face is visible.</p>

Solution	5.4.2, 5.6.3, 6.7.1, 6.A, 6.B
----------	-------------------------------

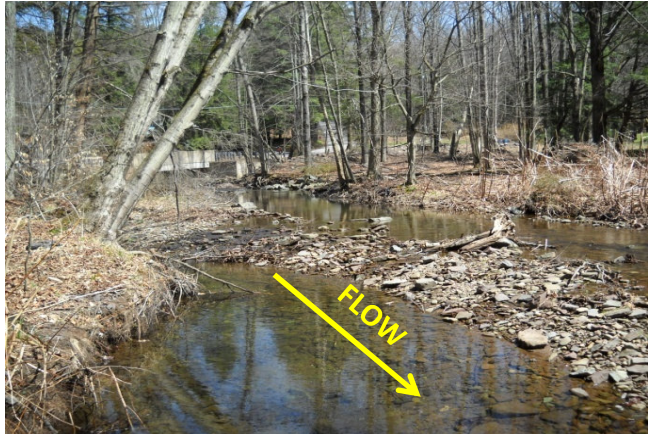
<p>Looking upstream toward Old State Road bridge showing significant erosion along both banks. A sediment bar is also forming in the middle of the channel.</p>

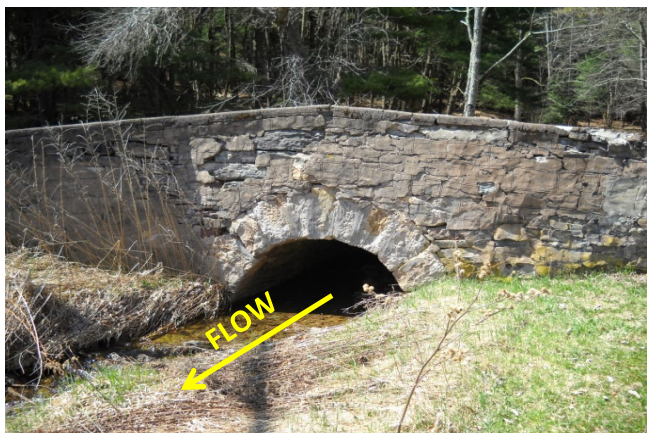
Description
	Downstream face of the Green Valley Road stone arch bridge.

Solution	5.4.2, 6.7.1, 6.A, 6.B
----------	------------------------

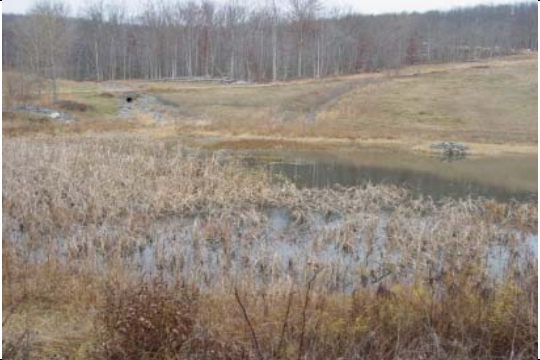
Problem Area ID:	SUG004	Inspected By/Date:	PAK 11/12/2008
Municipality:	Sugarloaf Township	Checked By/Date:	DEW 2/26/2010
Subwatershed:	Nescopeck Watershed

Explanation: This is a low area that collects and holds runoff and stays wet for extended periods. It has become a water quality issue due to acid mine drainage and sedimentation from a mine to the northeast. Options for correction include planting vegetation to act as a water quality bmp or reclamation of the mine.

Stream name:	Uncontrolled Runoff		
Drainage Area (mi ²):	0.57		
Calculation Method:	StreamStats		
C (Tc):	0.37 (30 min)		
Storm Frequency (Yrs)	Rainfall (in)	Peak Discharge (cfs)	Unit Discharge (cfs/Ac)
2	1.31	73	0.20
10	1.86	100	0.27
25	2.19	116	0.32
50	2.46	128	0.35
100	2.76	141	0.39
500	3.57	177	0.49
*Type of Problem (Highlight all that apply):		Description	
Flooding	Deficient Bridge/Culvert	Ponding area shown on several maps as a water body. It is believed that acid mine drainage from a mine to the northeast contaminates the water quality at this site.	
Erosion	Sedimentation		
Water/Groundwater Pollution	Other		
Potential Solutions			
The water pollution at the ponding area along Tomhicken Road has been identified as a problem area by the Municipality due to a history water quality issues. Based upon general field observations, this problem is believed to be storm runoff carrying acid mine drainage down gradient and ponding in a topographically low area. Possible solutions to this problem are A) planting appropriate vegetation in the low area to act as a filter/buffer or B) reclaim the mine. Further analysis would be required to analyze possible costs associated with these options.

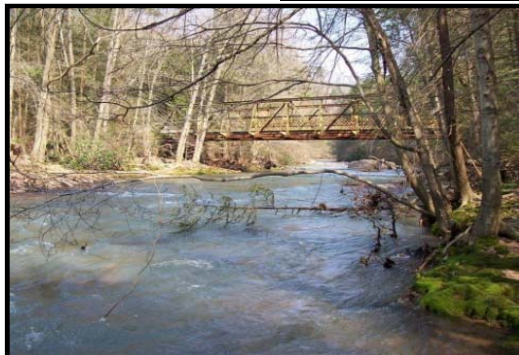
Explanation: Mill Hill Road Bridge is an old steel truss bridge that overtops on storm events due to the grade of the road. Currently a replacement bridge is in the final design stages.

Problem Area ID:	SUG005	Inspected By/Date:	PAK 11/26/2008
Municipality:	Sugarloaf Township	Checked By/Date:	DEW 2/26/2010
Subwatershed:	Nescopeck Watershed		
Stream name:	Nescopeck Creek		
Drainage Area (mi ²)	82.7		
Calculation Method	NSS StreamStats		
C (Tc)	N/A (N/A)		
Storm Frequency (Yrs)	Rainfall (in)	Peak Discharge (cfs)	Unit Discharge (cfs/Ac)
2	N/A	350	0.01
5	N/A	477	0.01
10	N/A	578	0.01
50	N/A	1,069	0.02
100	N/A	1,346	0.03
500	N/A	2,184	0.04
*Type of Problem (Highlight all that apply):		Description	
Flooding	Deficient Bridge/Culvert	Bridge carrying Mill Hill Road over Nescopeck Creek is an old steel overhead truss with a wooden deck. Due to the grade of the approach roadway, overtopping of the road occurs before the bridge deck.	
Erosion	Sedimentation		
Water/Groundwater Pollution	Other		
Potential Solutions			
The Mill Hill Rd. bridge has been identified as a problem area by the Conservation District due to a history of overtopping. This problem is due to the grade of the approach roadway being lower than the elevation of the deck. A bridge replacement project is in the final design phases. No further action required at this time.

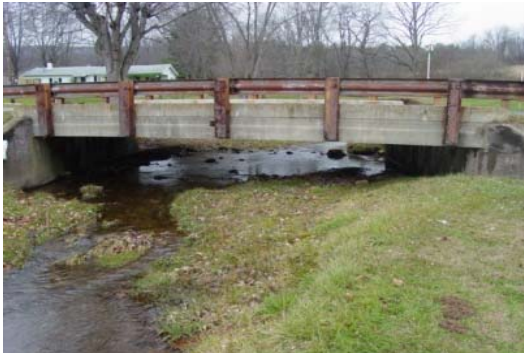
Problem Area ID:	SUG006	Inspected By/Date:	PAK 11/26/2008
Municipality:	Sugarloaf Township	Checked By/Date:	DEW 2/26/2010
Subwatershed:	Nescopeck Watershed

Explanation: A steel beam bridge carries Kisenwether Rd. over an unnamed tributary to Nescopeck Creek. The bridge is very low and tends to trap sediment as well as overtop on most storm events. Options for correction include removal of the debris as well as replacement of the bridge.

Stream name:	Nescopeck Creek		
Drainage Area (mi ²):	3.64		
Calculation Method:	USGS 2000-4189		
C (Tc):	N/A (N/A)		
Storm Frequency (Yrs)	Rainfall (in)	Peak Discharge (cfs)	Unit Discharge (cfs/Ac)
2	N/A	350	0.15
5	N/A	477	0.20
10	N/A	578	0.25
50	N/A	1,069	0.46
100	N/A	1,346	0.58
500	N/A	2,184	0.94
*Type of Problem (Highlight all that apply):		Description	
Flooding	Deficient Bridge/Culvert	Bridge has limited clearance to low chord which is believed to cause upstream flooding. Additionally, sediment accumulation is occurring on right side of channel which further restricts hydraulic opening.	
Erosion	Sedimentation		
Water/Groundwater Pollution	Other		
Potential Solutions			
The Kisenwether Rd. bridge has been identified as a problem area by the Conservation District due to a history of debris accumulation, downstream erosion, and upstream flooding. Based upon general field observations, this problem is believed to be caused by too small a hydraulic opening caused by the bridge low chords and accumulation of sediment and debris within the channel. Possible solutions to this problem are A) replacing the existing bridge to provide a higher low chord, B) removing sediment blocking the hydraulic opening.

Cost Estimates			
Option	A	B	C
Cost Range	\$50,000-\$200,000	\$5,000	N/A

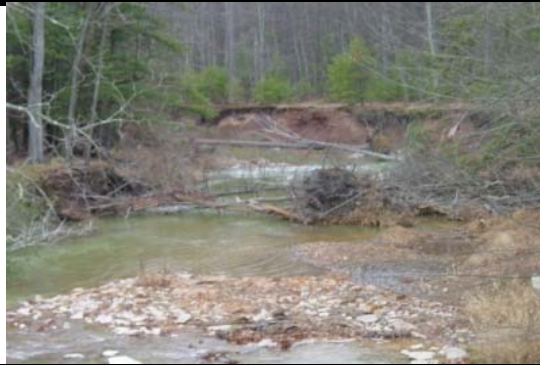
Problem Area ID:	SUG007 & SUG008	Inspected By/Date:	PAK 11/26/2008
Municipality:	Sugarloaf Township	Checked By/Date:	DEW 2/26/2010
Subwatershed:	Nescopeck Watershed

Explanation: Explanation: South of E. Country Road the stream is constricted and has a poor alignment. As a result, flooding could potentially occur on both the east and west banks. Water velocity appears extremely high. Severe downstream erosion has caused trees to collapse and debris to catch blocking the channel. Options for correction include removal of fallen trees and debris as well as bank stabilization.

Stream name:	Nescopeck Creek		
Drainage Area (mi ²):	13.8		
Calculation Method:	NSS StreamStats		
C (Tc):	N/A (N/A)		
Storm Frequency (Yrs)	Rainfall (in)	Peak Discharge (cfs)	Unit Discharge (cfs/Ac)
2	N/A	650	0.07
5	N/A	1,130	0.13
10	N/A	1,510	0.17
50	N/A	2,510	0.28
100	N/A	3,020	0.34
500	N/A	4,410	0.50
*Type of Problem (Highlight all that apply):		Description	
Flooding	Deficient Bridge/Culvert	Severe erosion downstream of the E. County Rd bridge and accumulation of debris/fallen trees obstructing flow. Erosion is believe to be caused by the Creek passing through a bend and high velocities exiting the constricted bridge opening.	
Erosion	Sedimentation		
Water/Groundwater Pollution	Other		
Potential Solutions			
<p>Streambank erosion downstream of the East Country Rd. Bridge has been identified by the Conservation District. Based upon general field observations, this problem is believed to be caused by an accumulation of sediment and debris at the bridge and a bend in the Creek. Possible implications are steep and hazardous stream banks, undercutting of the bank resulting in instability and loss of trees and vegetation, and downstream deposition of sediment . Possible solutions to this problem are A) restoring and armoring the stream banks through the bend, and B) removing accumulated debris and sediment at the bridge.</p>

Cost Estimates			
Option	A	B	C
Cost Range	\$10,000-\$20,000	\$5,000	N/A

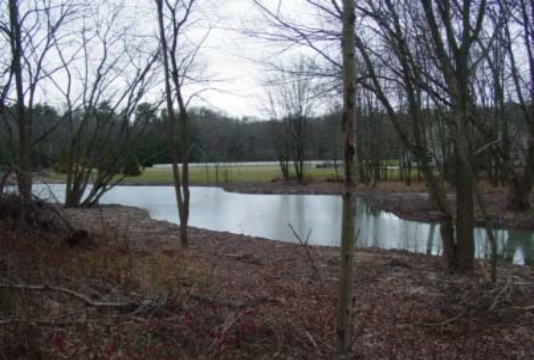
Problem Area ID:	SUG009	Inspected By/Date:	PAK 11/26/2008
Municipality:	Sugarloaf Township	Checked By/Date:	DEW 2/26/2010
Subwatershed:	Nescopeck Watershed

Explanation: This house is located just upstream of the confluence of Nescopeck Creek with an unnamed tributary, and is within the 100-year floodplains from both streams. Options to correct this problem are limited but include installing floodproofing measures around the house.

Stream name:	Nescopeck Creek		
Drainage Area (mi ²):	60.1		
Calculation Method:	NSS StreamStats		
C (Tc):	N/A (N/A)		
Storm Frequency (Yrs)	Rainfall (in)	Peak Discharge (cfs)	Unit Discharge (cfs/Ac)
2	N/A	2100	0.05
5	N/A	3510	0.09
10	N/A	4640	0.12
50	N/A	7680	0.20
100	N/A	9210	0.24
500	N/A	13400	0.35
*Type of Problem (Highlight all that apply):		Description	
Flooding	Deficient Bridge/Culvert	A recently constructed home appears to be located in the Nescopeck Creek floodplain. Flooding and ponding have occurred at the property. Stream bank stabilization measures were noticed along the Nescopeck Creek.	
Erosion	Sedimentation		
Water/Groundwater Pollution	Other		
Potential Solutions			
<p>Repeated flooding at a home located off of Kisenwether Road has been identified by the Conservation District. Based upon general field observations, this problem is believed to be caused by a structures location in the FEMA floodplain with a floor elevation below flood elevation. Possible solutions to this problem are A) apply flooding proof measure to structures or B) constructing a flood wall or levee. Due to the complexity of this problem, further investigation would be required to determine probable costs for these solutions.</p>

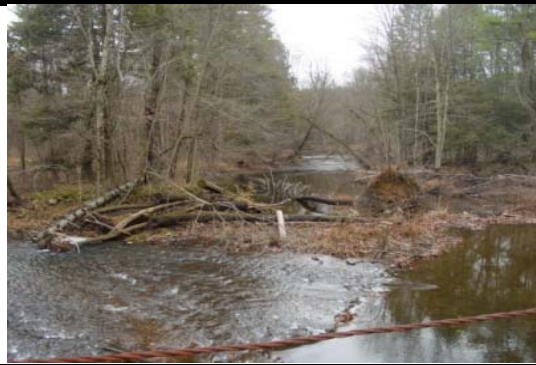
Problem Area ID:	SUG010	Inspected By/Date:	PAK 11/26/2008
Municipality:	Sugarloaf Township	Checked By/Date:	DEW 2/26/2010
Subwatershed:	Nescopeck Watershed

Explanation: Red Bridge Lane Bridge is an old steel truss bridge that is closed to the public. Directly downstream of this bridge are fallen trees and other debris accumulation near the split between the main and secondary channels.

Stream name:	Nescopeck Creek		
Drainage Area (mi ²):	64.6		
Calculation Method:	NSS StreamStats		
C (Tc):	N/A (N/A)		
Storm Frequency (Yrs)	Rainfall (in)	Peak Discharge (cfs)	Unit Discharge (cfs/Ac)
2	N/A	2,250	0.05
5	N/A	3,760	0.09
10	N/A	4,970	0.12
50	N/A	8,210	0.20
100	N/A	9,840	0.24
500	N/A	14,300	0.35
*Type of Problem (Highlight all that apply):		Description	
Flooding	Deficient Bridge/Culvert	Fallen trees and sediment accumulation downstream of bridge are causing a flow obstruction.	
Erosion	Sedimentation		
Water/Groundwater Pollution	Other		
Potential Solutions			
Sediment and debris accumulation downstream of the Red Bridge Lane bridge over Nescopeck Creek has been identified as a problem area by the Conservation District. Based upon general field observations, this problem is believed to be caused by the flow confluence of the Nescopeck Creek and the Little Nescopeck Creek. A possible solution to this problem is to A) conduct regular maintenance to remove debris and sediment.

Cost Estimates			
Option	A	B	C
Cost Range	\$5,000/year	N/A	N/A

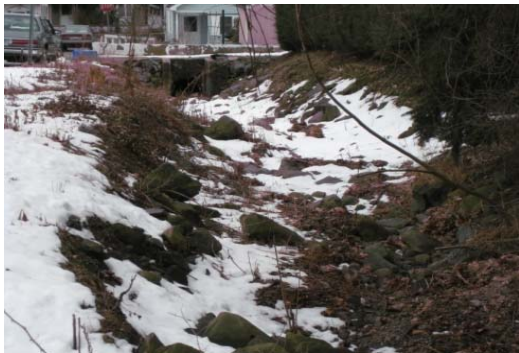
Problem Area ID:	SWO001	Inspected By/Date:	SDB 3/19/2009
Municipality:	Swoyersville Borough	Checked By/Date:	DEW 3/9/2010
Subwatershed:	Abrahams Creek

Explanation: Swoyersville Borough reported flooding near the intersection of Brook Street and Main Street. Facing north a small drainage swale is located along the left side of Brook Street. Stormwater leaves the swale through a 36 inch culvert. The culvert is over 100 feet long and discharges to a channelized drainage system of the other side of Main Street.

Stream name:	N/A		
Drainage Area (mi ²):	0.0791		
Calculation Method:	SCS		
Curve Number; Lag:	77.26; 27.35 min		
Storm Frequency (Yrs)	Rainfall (in)	Peak Discharge (cfs)	Volume (AC-FT)
2	2.53	32	3.08
5	3.14	52	4.79
10	3.68	63	6.08
25	4.54	81	8.58
50	5.34	99	11.02
100	6.28	117	13.63
*Type of Problem (Highlight all that apply):		Description	
Flooding	Deficient Bridge/Culvert	Swoyersville Borough reported flooding near the intersection of Brook Street and Main Street. Facing north a small drainage swale is located along the left side of Brook Street. Stormwater leaves the swale through a 36 inch culvert. The culvert is over 100 feet long and discharges to a channelized drainage system of the other side of Main Street.	
Erosion	Sedimentation		
Water/Groundwater Pollution	Other

Potential Solutions			
<p>Flooding at the intersection of Brook Street and Main Street have been identified by the Municipality. Based upon general field observations these problems are most likely due to the existing stormwater conveyance system inadequacy, and debris accumulating in the upstream channel, thus reducing the capacity of the channel over time. Possible solutions to these problems include A) replacing the culvert with a larger structure; B) restore and regrade channel to increase capacity;</p>			
Cost Estimates			
Option	A	B	C
Cost Range	\$50,000-\$250,000	\$50,000-\$200,000	N/A

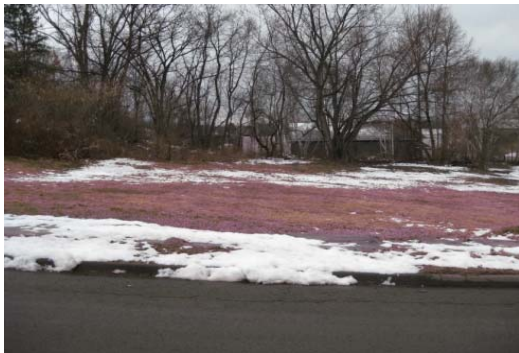
Problem Area ID:	SWO002	Inspected By/Date:	SDB 3/19/2009
Municipality:	Swoyersville Borough	Checked By/Date:	DEW 3/9/2010
Subwatershed:	Abrahams Creek

Explanation: Swoyersville Borough reported flooding near the intersections of Owen Street with Main Street. Runoff from the mountain appears to collect in a low lying area at the intersection of Owen Street and Main Street.

Stream name:	N/A		
Drainage Area (mi ²):	0.1052		
Calculation Method:	SCS		
Curve Number; Lag:	71.06; 27.35 min		
Storm Frequency (Yrs)	Rainfall (in)	Peak Discharge (cfs)	Volume (AC-FT)
2	2.53	22	2.60
5	3.14	44	4.44
10	3.68	54	5.71
25	4.54	74	8.44
50	5.34	94	11.16
100	6.28	112	13.94
*Type of Problem (Highlight all that apply):		Description	
Flooding	Deficient Bridge/Culvert	Swoyersville Borough reported flooding near the intersections of Owen Street with Main Street. Runoff from the mountain appears to collect in a low lying area at this location.	
Erosion	Sedimentation		
Water/Groundwater Pollution	Other		
Potential Solutions			
Runoff from the mountain appears to collect in a low lying area near the intersection. A drainage ditch is located upstream of the low lying area, however, no outlet could be located to effectively convey runoff to the downstream conveyance system. Possible solutions to this problem include: A) design and construct an engineered channel to route runoff around the low lying area; B) install a stormwater collection system and route to Main Street to discharge the runoff downstream.

Cost Estimates			
Option	A	B	C
Cost Range	\$50,000 - \$250,000	\$50,000 - \$250,000	N/A

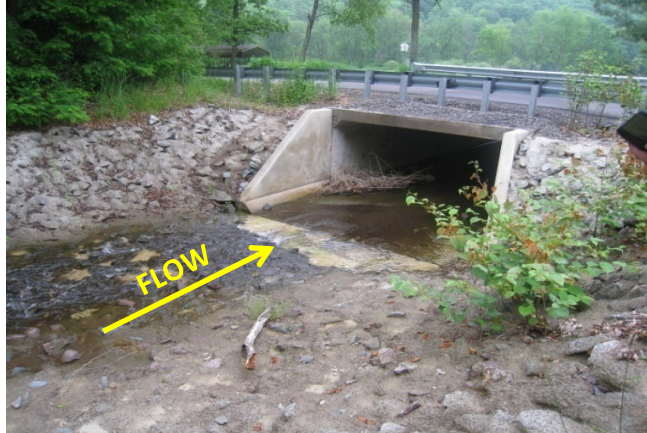
Problem Area - Map ID:	UNI001	Comments
Municipality:	Union Township	This problem area was reported by the Luzerne County Conservation District. Flooding, streambank erosion, dead fish, and a collapsed bridge were all reported at this site, which is located at the northwest corner of Shickshinny Lake. A property owner indicated that after the 2006 flood, 2 pipe culverts at this location were replaced with this bridge by FEMA. The property owner was unaware of any issues at this location since the replacement.
Subwatershed:	Susquehanna River	
Stream name:	Shickshinny Creek/ Lake	
Inspected By/Date:	PAK 5/28/2009	
Checked By/Date:	MJW 1/7/2010	
Type of Problem (Highlighted):		
1	Flooding	
2	Deficient bridge/culvert	
3	Erosion	
4	Sedimentation	
5	Water/Groundwater Pollution	
6	Other

Description
	Looking downstream at the upstream face of the new Main St. bridge that replaced the two older pipes.

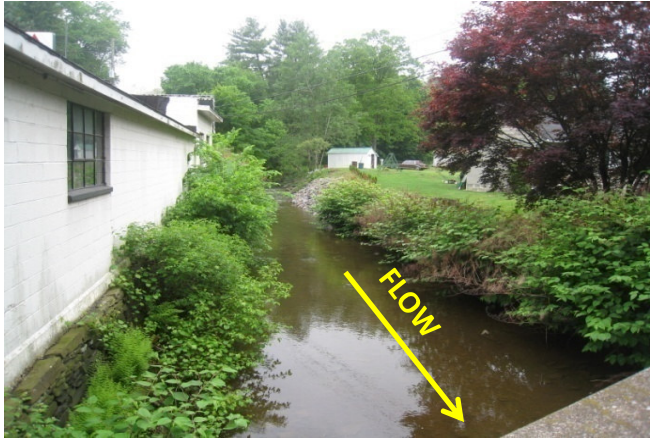
Problem Area - Map ID:	UNI002	Comments
Municipality:	Union Township	Forms provided by the Conservation District indicate that Cragle Hill Rd. bridge is partially washed out and erosion is occurring at the location near an adjacent garage. No evidence of a washed out bridge was visible during the field observation. Riprap was placed on the eroded area of the bank.
Subwatershed:	Susquehanna River	
Stream name:	Shickshinny Creek	
Inspected By/Date:	PAK 5/28/2009	
Checked By/Date:	MJW 1/8/2010	
Type of Problem (Highlighted):		
1	Flooding	
2	Deficient bridge/culvert	
3	Erosion	
4	Sedimentation	
5	Water/Groundwater Pollution	
6	Other

</div> <div style="width: 50%; padding-left: 10px;"> <p>View from McKendree Road bridge looking upstream. Structure to left of stream is supported by retaining wall along stream bank. The streambank on right side of photo is steep with an area of riprap. The garage along the right side streambank is not visible in this picture.</p> </div>

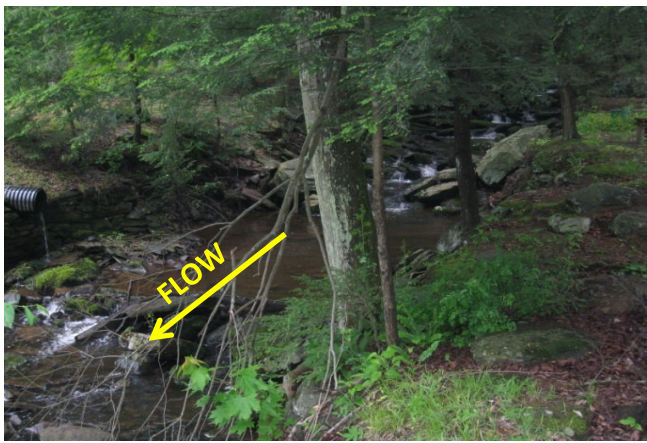
Problem Area - Map ID:	UNI003	Comments The Conservation District reported streambank erosion as well as problems with the hydraulic opening of the Mountain Road culvert, stream crossing issues and road problems. This area has historic significance and community recreation.
Municipality:	Union Township	
Subwatershed:	Susquehanna River	
Stream name:	Herron Creek	
Inspected By/Date:	PAK 5/28/2009	
Checked By/Date:	MJW 1/8/2010	
Type of Problem (Highlighted):		
1	Flooding	
2	Deficient bridge/culvert	
3	Erosion	
4	Sedimentation	
5	Water/Groundwater Pollution	
6	Other

Description
	Looking upstream from Mountain Road culvert. An outlet pipe is located on the right discharging from the top of a stone retaining wall. The bank to the left is fairly steep. The Mountain Road culvert is most likely under an inlet control condition due to the steep channel gradient. Increased velocities through the culvert and shallower gradient downstream are likely causing erosion.

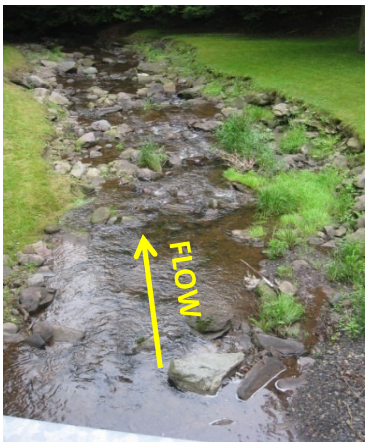
Description
	Looking downstream from Mountain Road culvert. The floodplain in this area appears to be very wide, with the grass mowed to the banks, resulting in minimal buffer area. Erosion seems to be more prevalent along the right bank.

Solution	5.4.1, 5.4.2, 5.6.3, 6.7.1, 6.A, 6.C
----------	--------------------------------------

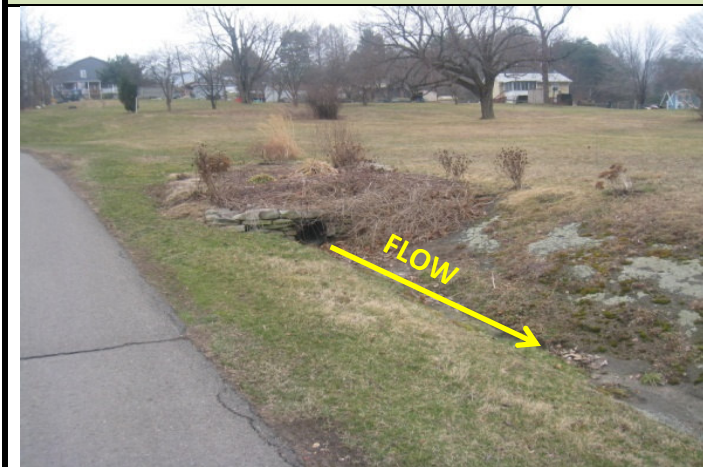
Photo of culvert outlet to *drainage swale*. The origin of the culvert shown could not be determined as the pipe originated from private property marked with no trespassing signs. Based on the size of the culvert inlet and swale size, it appears that the swale would be able to handle most storm events.

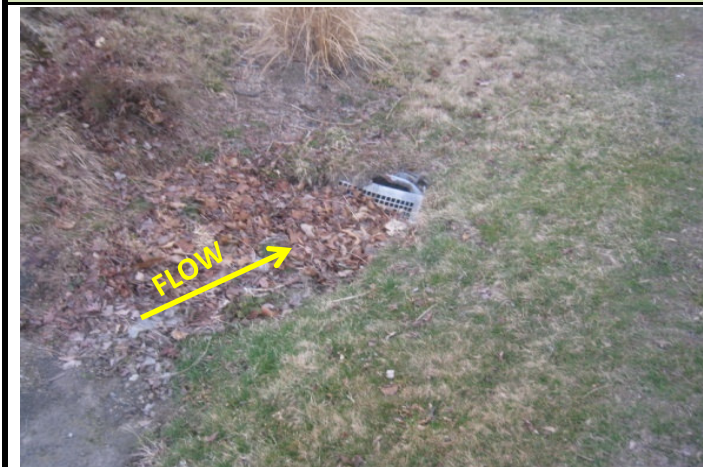
Downstream end of swale shown in the previous photo. Based upon the size of the upstream swale, this culvert is likely undersized. Additionally, the culvert inlet is partially blocked by debris.

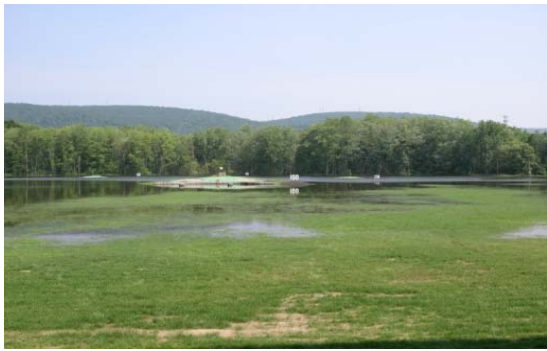
Problem Area ID:	WWB001	Inspected By/Date:	SDB 3/19/2009
Municipality:	West Wyoming Borough	Checked By/Date:	DEW 3/9/2010
Subwatershed:	Abrahams Creek

Explanation: Inadequate conveyance and a high water table cause the low-lying property on Rich's Golf Center to become inundated during storm events. The area is flat, and the receiving channel has minimal grade. This causes ponded water to stagnate for extended periods after the rainfall events.

Stream name:	Abrahams Creek		
Drainage Area (mi ²):	0.28		
Calculation Method:	SCS		
Curve Number; Lag:	64.77; 62 min		
Storm Frequency (Yrs)	Rainfall (in)	Peak Discharge (cfs)	Volume (AC-FT)
2	2.53	40	9.23
5	3.14	61	13.95
10	3.68	82	18.62
25	4.54	120	26.81
50	5.34	158	35.09
100	6.28	206	45.43
*Type of Problem (Highlight all that apply):		Description	
Flooding	Deficient Bridge/Culvert	Inadequate conveyance and a high water table cause the low-lying property on Rich's Golf Center to become inundated during storm events. The area is flat, and the receiving channel has minimal grade. This causes ponded water to stagnate for extended periods after the rainfall events.	
Erosion	Sedimentation		
Water/Groundwater Pollution	Other		
Potential Solutions			
Possible solutions to the ponding water on the Rich's Golf Center property include: A) construct a low berm around the edge of the property to prevent external runoff from entering, and pump water off of property; B) regrade downstream Abrahams Creek channel and construct feeder channels to remove water from property.

Cost Estimates			
Option	A	B	C
Cost Range	\$100,000 - \$500,000	\$100,000 - \$500,000	N/A

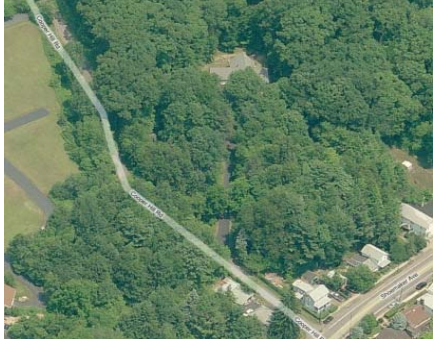
Problem Area ID:	WWB003	Inspected By/Date:	SDB 3/19/2009
Municipality:	West Wyoming Borough	Checked By/Date:	DEW 3/9/2010
Subwatershed:	Abrahams Creek

Explanation: West Wyoming Borough reported erosion and sedimentation occurring along Copper Hill Road and Shoemaker Avenue, which has resulted in flooding.

Stream name:	N/A		
Drainage Area (mi ²):	0.1739		
Calculation Method:	SCS		
Curve Number; Lag:	68.93; 29.16 min		
Storm Frequency (Yrs)	Rainfall (in)	Peak Discharge (cfs)	Volume (AC-FT)
2	2.53	26	3.59
5	3.14	57	6.38
10	3.68	70	8.24
25	4.54	99	12.39
50	5.34	129	16.57
100	6.28	152	20.74
*Type of Problem (Highlight all that apply):		Description	
Flooding	Deficient Bridge/Culvert	West Wyoming Borough reported erosion and sedimentation occurring along Copper Hill Road and Shoemaker Avenue, which has resulted in flooding.	
Erosion	Sedimentation		
Water/Groundwater Pollution	Other		
Potential Solutions			
To address the the erosion of the channel, and reduce flooding, the possible solutions are A) stabilize channel; B) design and construct a secondary channel to improve flow conditions in the primary channel; C) upstream energy dissipation or storage facility.

Cost Estimates			
Option	A	B	C
Cost Range	\$25,000 - \$150,000	\$50,000 - \$250,000	\$50,000 - \$250,000

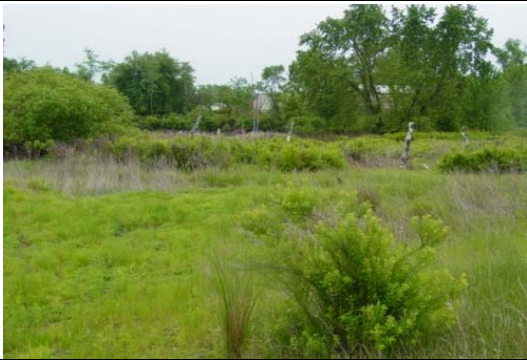
Problem Area ID:	WWB004	Inspected By/Date:	SDB 3/19/2009
Municipality:	West Wyoming Borough	Checked By/Date:	DEW 3/9/2010
Subwatershed:	Abrahams Creek

Explanation: The Moonlite Drive-In property is in a low lying area, and runoff from the mountain and Dimmick's Creek that enters the property cannot effectively be discharged. The abandoned railroad grade that bounds the property acts as a berm which keeps water confined to the property.

Stream name:	Dimmick's Creek		
Drainage Area (mi ²):	0.9058		
Calculation Method:	SCS		
Curve Number; Lag:	72.83; 31.54 min		
Storm Frequency (Yrs)	Rainfall (in)	Peak Discharge (cfs)	Volume (AC-FT)
2	2.53	206	25.54
5	3.14	384	42.37
10	3.68	471	54.31
25	4.54	633	79.15
50	5.34	797	103.79
100	6.28	943	129.28
*Type of Problem (Highlight all that apply):		Description	
Flooding	Deficient Bridge/Culvert	The Moonlite Drive-In property is in a low lying area, and runoff from the mountain and Dimmick's Creek that enters the property cannot be effectively discharged. The abandoned railroad grade that bounds the property acts as a berm which keeps water confined to the property.	
Erosion	Sedimentation		
Water/Groundwater Pollution	Other		
Potential Solutions			
Possible solutions to removing/preventing water from ponding on the Moonlite Drive-In property are: A) construct a storage area and channel network to direct runoff to the storage system; B) regrade the lower portion of the property and install new pipes under the railroad bed; C) install pumps and pump water to adjacent storage areas.

Cost Estimates			
Option	A	B	C
Cost Range	\$50,000 - \$250,000	\$100,000 - \$300,000	\$50,000 - \$500,000

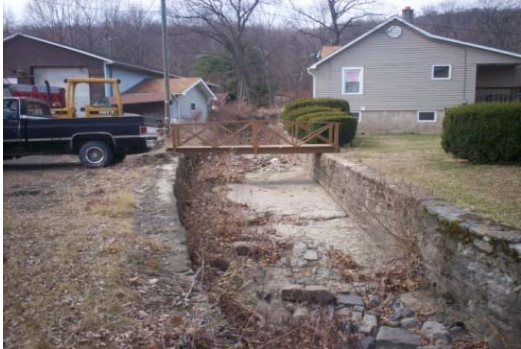
Problem Area ID:	WWB005	Inspected By/Date:	SDB 3/19/2009
Municipality:	West Wyoming Borough	Checked By/Date:	DEW 3/9/2010
Subwatershed:	Abrahams Creek

Explanation: Upstream of the culvert carrying Dimmick's Creek under Shoemaker Avenue, the stream channel is severely eroded and flooding has been noted during storm events..

<p>Flooding and erosion have been reported upstream of the culvert carrying Dimmick's Creek under Shoemaker Avenue. Possible solutions to this problem are: A) increase the capacity of the channel and perform channel stabilization; B) construct an upstream storage facility to decrease flows in the channel.</p>			
Cost Estimates			
Option	A	B	C
Cost Range	\$100,000 - \$250,000	\$100,000 - \$250,000	N/A

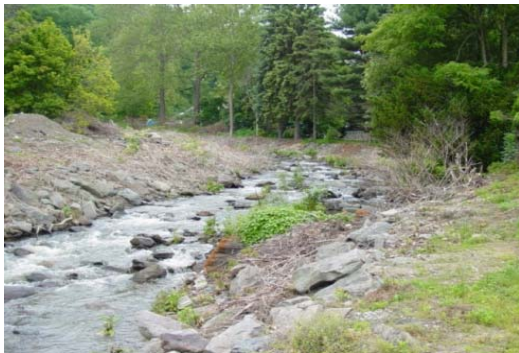
Problem Area ID:	WWB006	Inspected By/Date:	SDB 3/19/2009
Municipality:	West Wyoming Borough	Checked By/Date:	DEW 3/9/2010
Subwatershed:	Abrahams Creek

Explanation: Streambank erosion and destabilization during past storm events have washed material from the bank and has resulted in flooding along the Abrahams Creek stream reach between the Upper 8th Street bridge and the debris basin.

Stream name:	Abrahams Creek		
Drainage Area (mi ²):	10.29		
Calculation Method:	SCS		
Curve Number; Lag:	Calibrated for multiple subareas		
Storm Frequency (Yrs)	Rainfall (in)	Peak Discharge (cfs)	Stream Velocity (ft/s)
2	2.53	582	<15
5	3.14	1,040	~15
10	3.68	1,275	15-20
25	4.54	1,807	15-20
50	5.34	2,310	~20
100	6.28	2,750	>20
*Type of Problem (Highlight all that apply):		Description	
Flooding	Deficient Bridge/Culvert	Streambank erosion and destabilization during past storm events have washed material from the bank and has resulted in flooding along the Abrahams Creek stream reach between the Upper 8th Street bridge and the debris basin.	
Erosion	Sedimentation		
Water/Groundwater Pollution	Other		
Potential Solutions			
Possible solutions to the stream degradation and flooding on the Abrahams Creek between the Upper 8th Street bridge and the debris basin include: A) channel realignment to restore the channel to its original course and capacity, including riparian buffer restoration; B) in-stream energy dissipation to decrease stream velocities; C) channel stabilization and bank protection.

Cost Estimates			
Option	A	B	C
Cost Range	\$100,000 - \$300,000	\$100,000 - \$300,000	\$50,000 - \$300,000

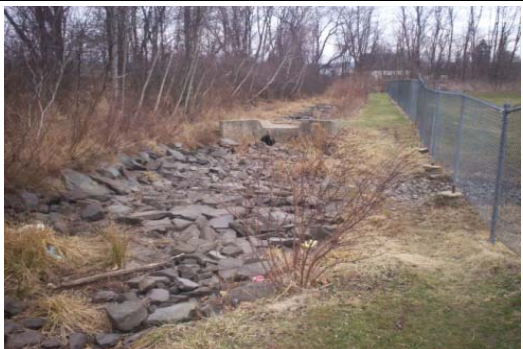
Problem Area ID:	WWB007	Inspected By/Date:	SDB 3/19/2009
Municipality:	West Wyoming Borough	Checked By/Date:	DEW 3/9/2010
Subwatershed:	Abrahams Creek

Explanation: The low-lying area between West Wyoming Borough and Exeter Borough known as Ferretti Pond backs up and inundates adjacent properties due to an ineffective discharge mechanism to the pump station at 5th Street.

Stream name:	Ferretti Pond		
Drainage Area (mi ²):	0.7832		
Calculation Method:	SCS		
Curve Number; Lag:	70; 37 min		
Storm Frequency (Yrs)	Rainfall (in)	Peak Inflow : Peak Outflow (cfs)	Volume (AC-FT)
2	2.53	0 : 103	17.64
5	3.14	10 : 212	30.70
10	3.68	21 : 260	39.56
25	4.54	65 : 361	58.90
50	5.34	142 : 465	78.31
100	6.28	218 : 548	97.85
*Type of Problem (Highlight all that apply):		Description	
Flooding	Deficient Bridge/Culvert	The low-lying area between West Wyoming Borough and Exeter Borough known as Ferretti Pond backs up and inundates adjacent properties due to an ineffective discharge mechanism to the pump station at 5th Street.	
Erosion	Sedimentation		
Water/Groundwater Pollution	Other		
Potential Solutions			
Water in the Ferretti Pond is not effectively conveyed to the pump station at 5th Street which pumps water to the Abrahams Creek. Possible solutions to this problem include: A) construct a channel to convey water to the pump; B) construct berm to prevent water from inundating the adjacent properties; C) extend pump intake to operate in the pond at a set level.

Cost Estimates			
Option	A	B	C
Cost Range	\$100,000 - \$200,000	\$100,000 - \$200,000	\$100,000 - \$300,000

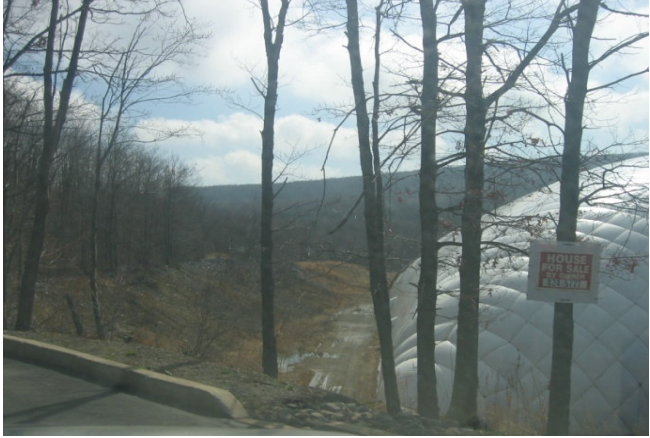
<p>This photo shows the area downstream of the housing development. Unprotected soil is visible surrounding the Wyoming Valley Sports Dome. Locations of stormwater ponding and erosion were visible.</p>

Solution	5.4.2, 5.4.3, 5.6.3, 6.4.5, 6.6.2, 6.A Channel Construction
----------	---

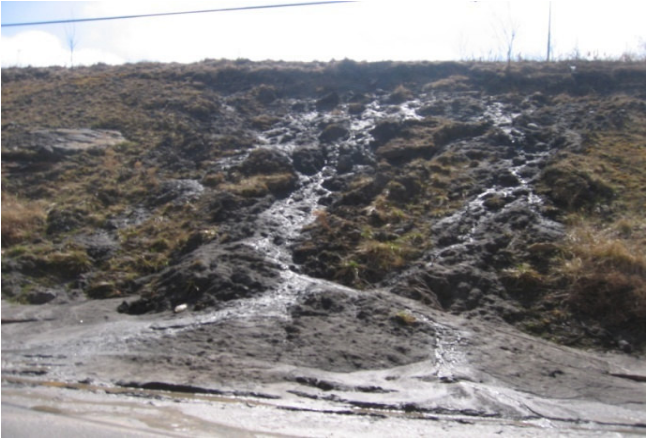
</div> <div style="width: 5%;"></div> <div style="width: 45%;"> <p>Heavy erosion behind other areas of the shopping center was also observed. The soil appeared saturated and the bank erosion more recent. Runoff from Interstate 81 appears to contribute to damage in this area. A small stormwater basin was constructed, but has been blown out in past events. The basin requires retrofitting to accommodate larger volumes of runoff.</p> </div>

Solution	5.4.3, 5.6.3, 6.A
----------	-------------------

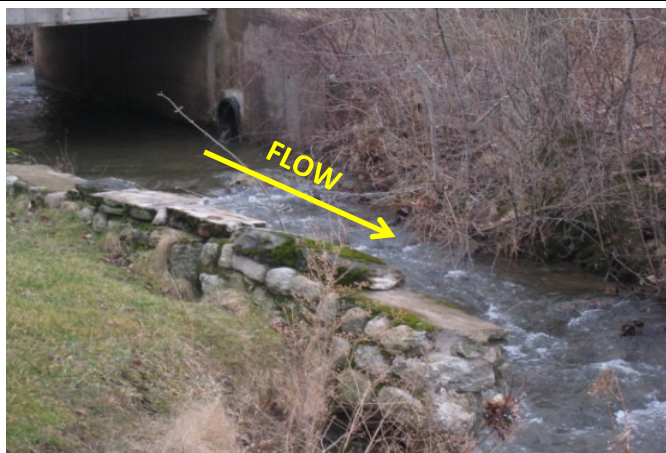
Downstream face of the Church Rd. (upstream) bridge is shown in this photo. Site observations indicate that this bridge appears to be interrupting the sediment transport capabilities of the channel, causing sedimentation upstream of this bridge and erosion downstream. Erosion and associated undermining of the stone retaining wall in the foreground was observed.

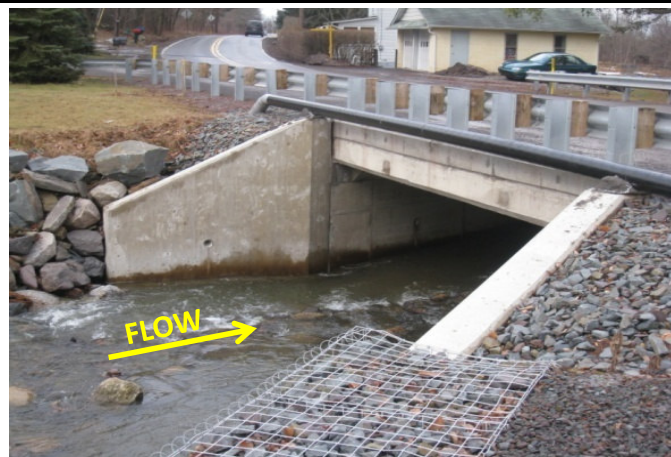
Upstream face of the S. Main St. (downstream) bridge. It appears that recent construction has occurred based upon visual inspection of the guiderail, riprap, gabion baskets, wingwalls, and utility pipe. Stream stabilization to minimize streambank erosion is visible at this location.

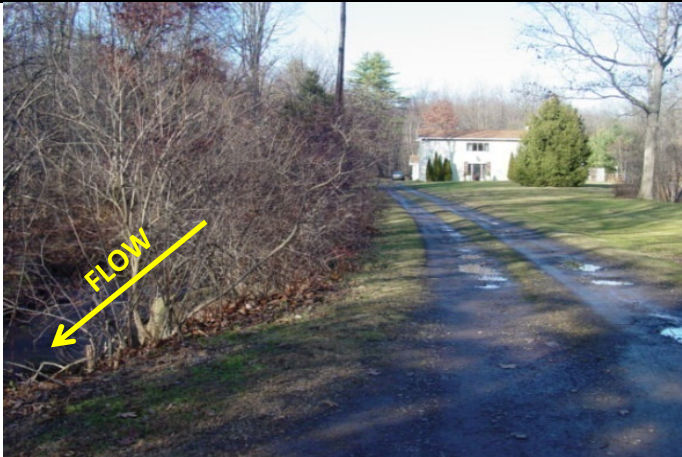
<p>Looking upstream from Oak Drive. <i>Private</i> driveway in photo extends from the end of Oak Drive to dwelling. Stream is located approximately 5 feet to left of drive. The opposite side of the stream is wooded.</p>

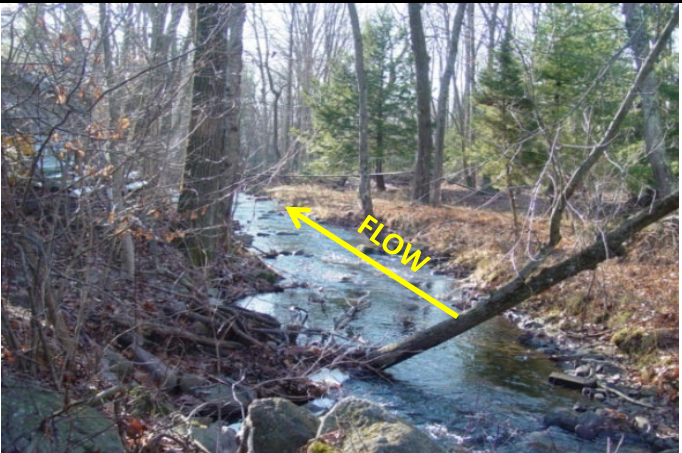
<p>Looking downstream from the start of the private drive, the channel bends and meanders perpendicular to Oak Drive. The creek is shallow and there is a possibility that larger storms may flood the private driveway or Oak Drive.</p>

Solution	5.4.2, 5.6.3, 6.4.5, 6.7.1, 6.A, 6.D
----------	--------------------------------------

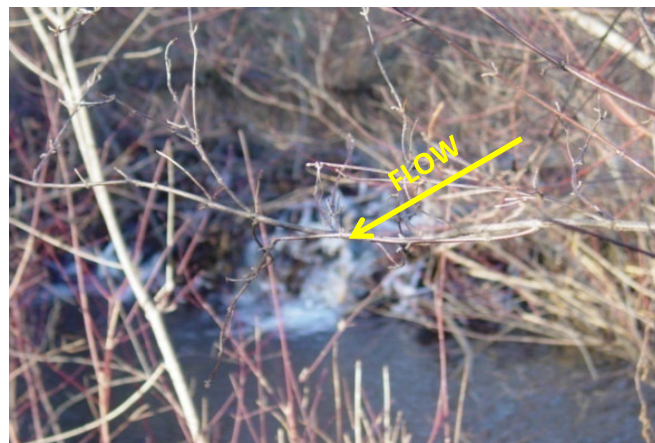
Description
	Photo of beaver dam resulting in significant obstruction to flow, causing rise in water levels. From discussion with a local homeowner, high water marks are present and can be seen 4 feet above the ground level.
